Mexic-Arte Museum
Building Survey and
Feasibility Analysis

June 27, 2011

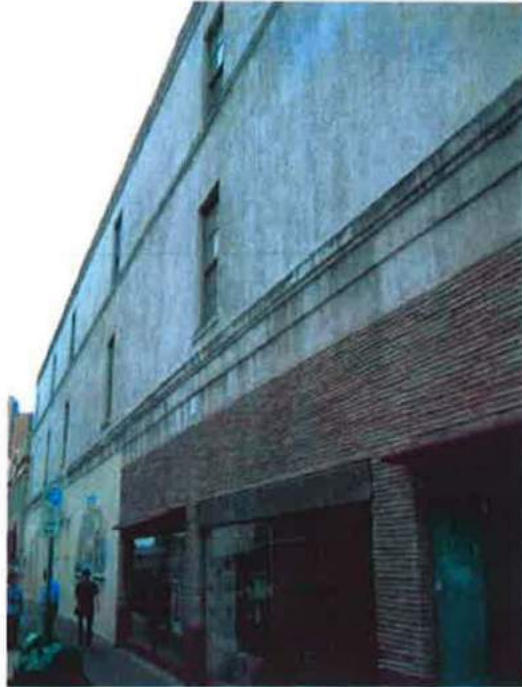
Photo 1, North Wall, with Tension Rod Plate Under Window

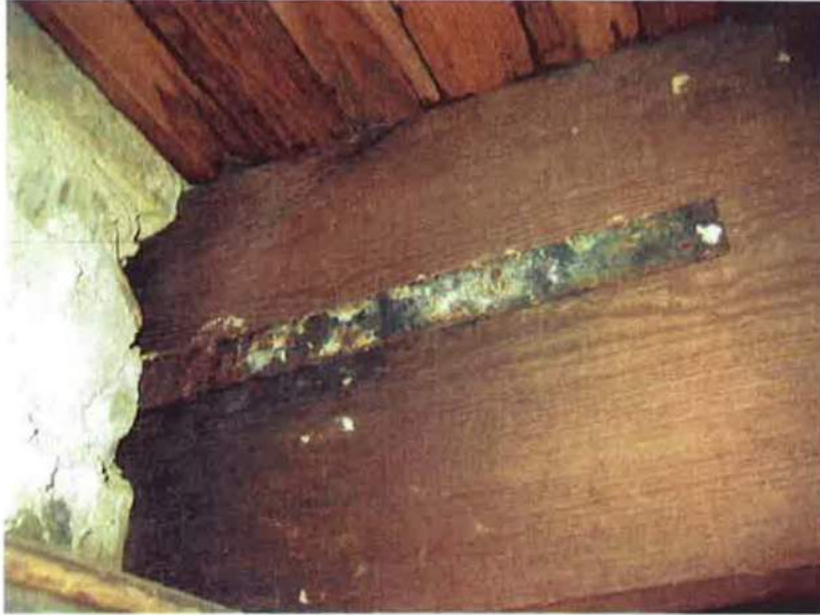
Photo 3, Third Level Joists w/ Strap Tie

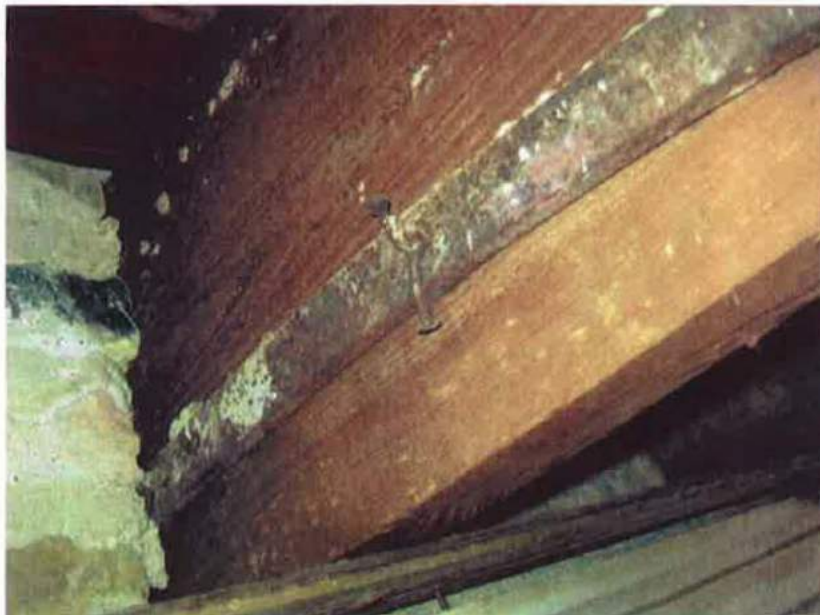
Photo 4, Third Level Joists w/ Strap Tie

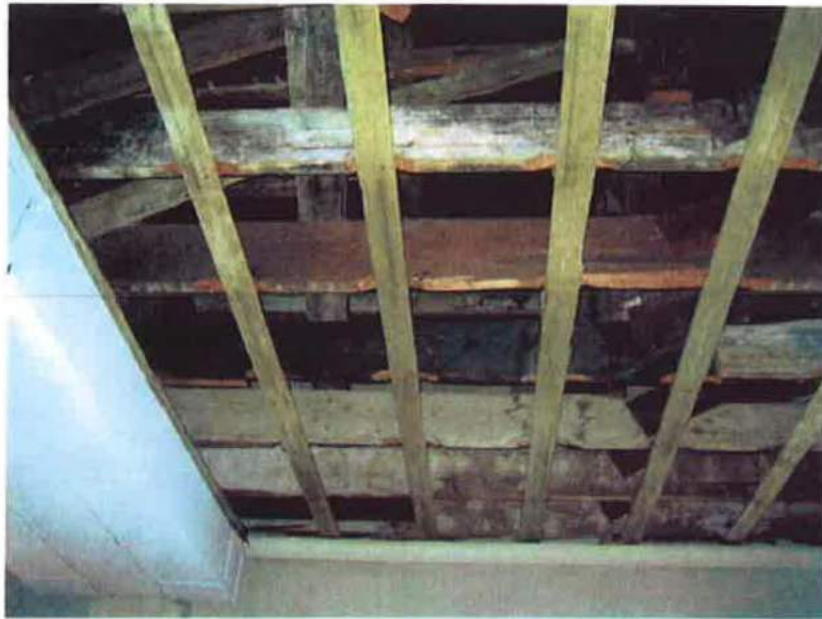
Photo 7, Roof Framing, Notched

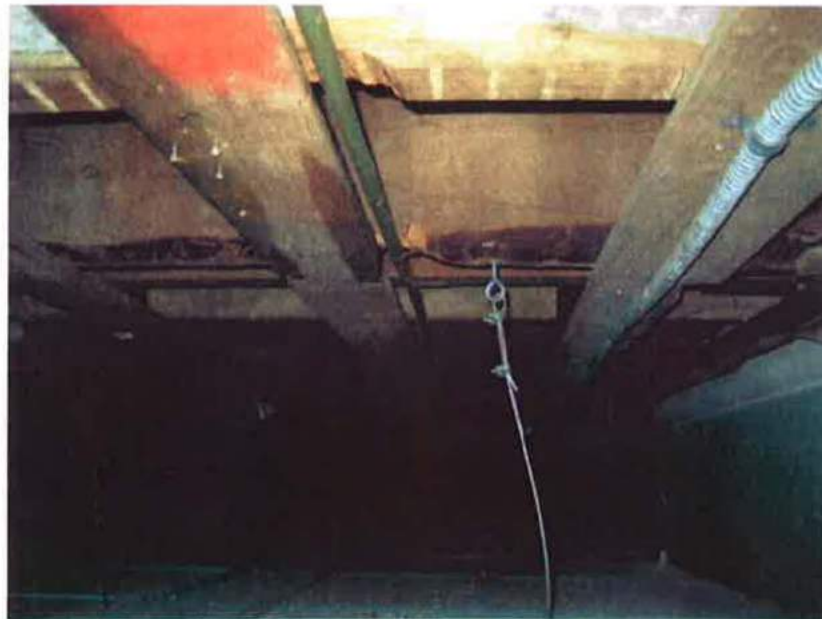
- c. Inconsistent and fair to poor condition of the existing wood floor joists framed into the existing masonry walls i.e. notched, water damaged
 - d. Shallow spread footings were considered in lieu of drilled piers, however given the soil conditions and estimated bearing capacities, they would need to be very large and deep. Given that these spread footings would be constructed inside the existing walls and foundations, the potential for eccentric loading and over-stressing the soils on one side of the footing, made this foundation option less desirable.

Photo 8, Floor Joists, Notched

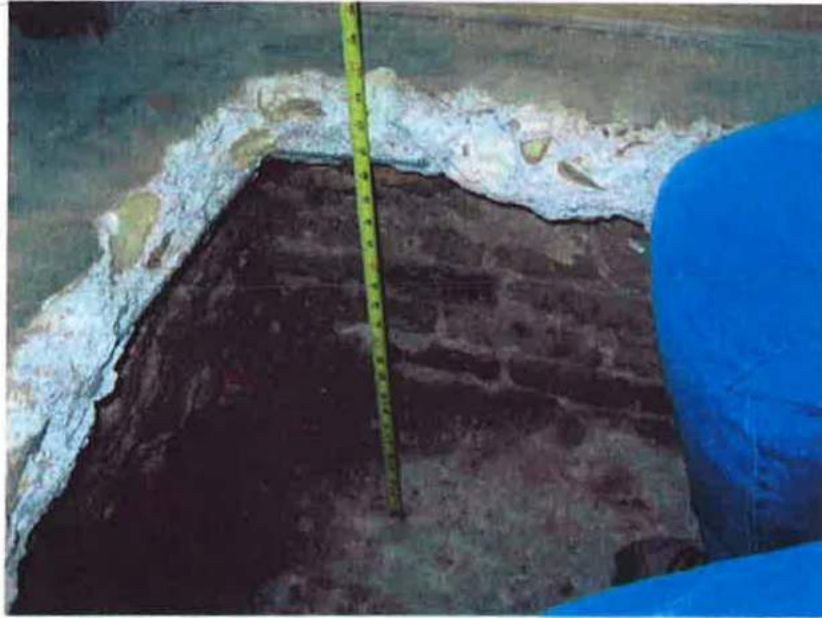
Photo 9, Northeast Corner, Depth to Concrete Footing

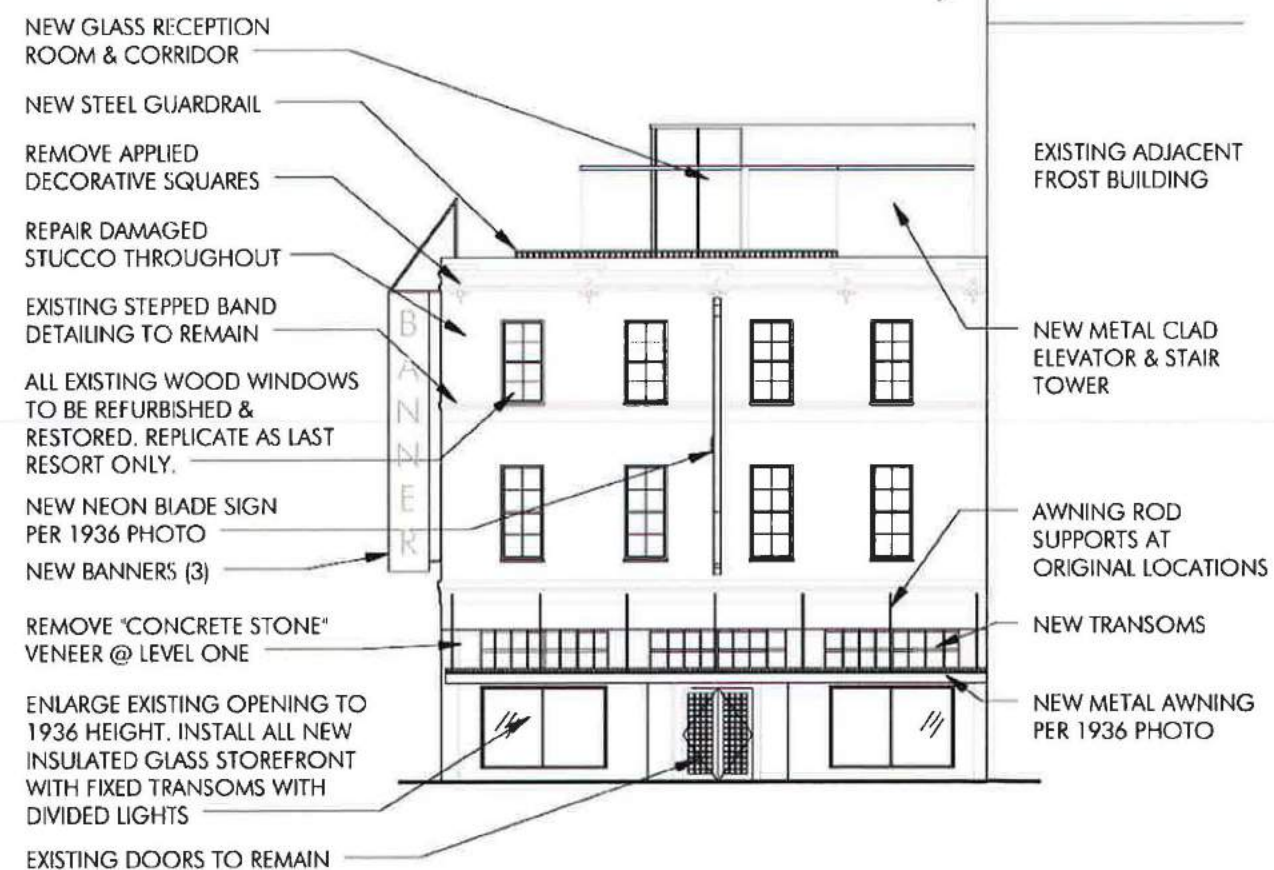
1 PROPOSED WEST ELEVATION
1/4" = 1'-0"

EXTERIOR ELEMENTS TO BE RESTORED PER 1936 HISTORIC PHOTO.

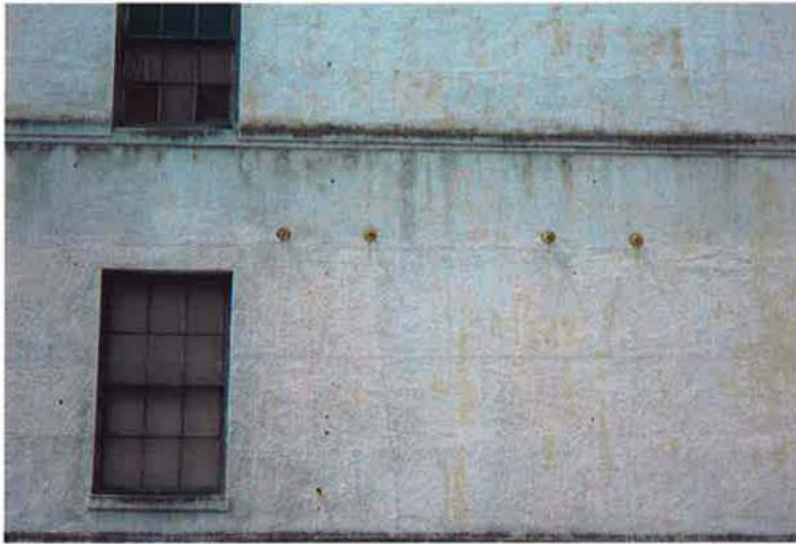
Photo 1
Unknown "through-wall"
penetrations

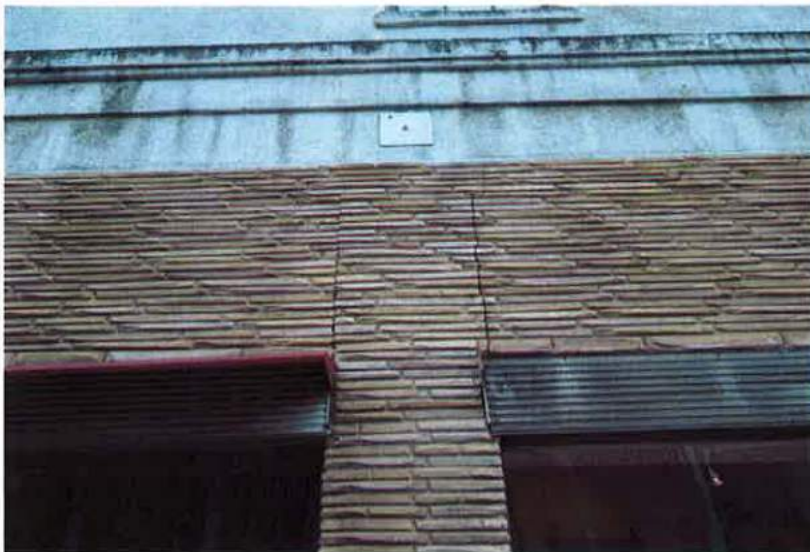
Photo 2
Veneer Cracking above storefront
NOTE: tie rod end plate

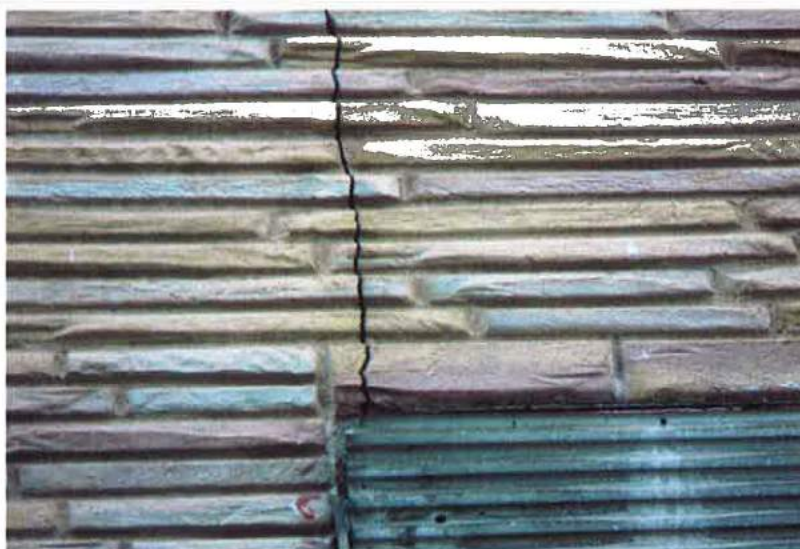
Photo 3
Close up of Photo 2 area

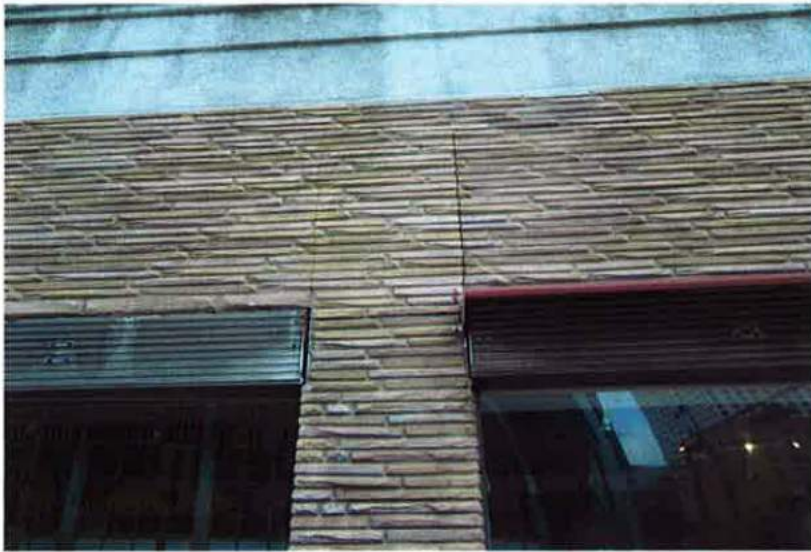
Photo 4
Veneer Cracking above store front

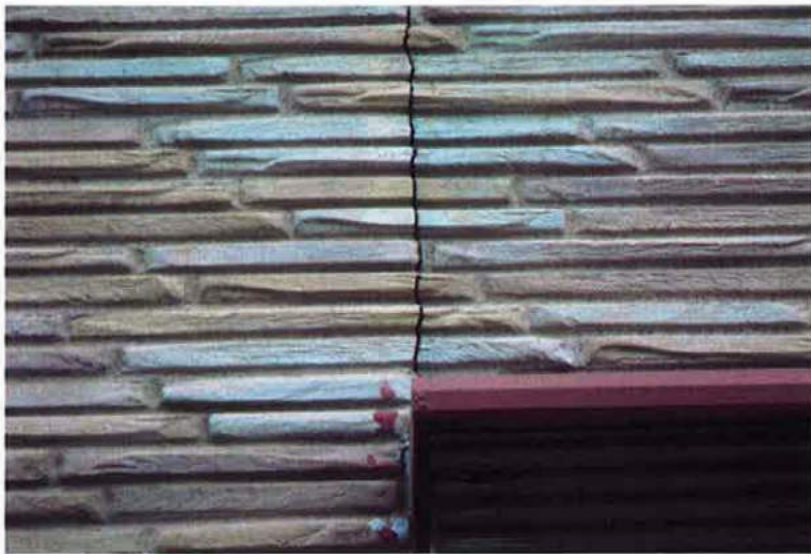
Photo 5
Close up of Photo 4 area

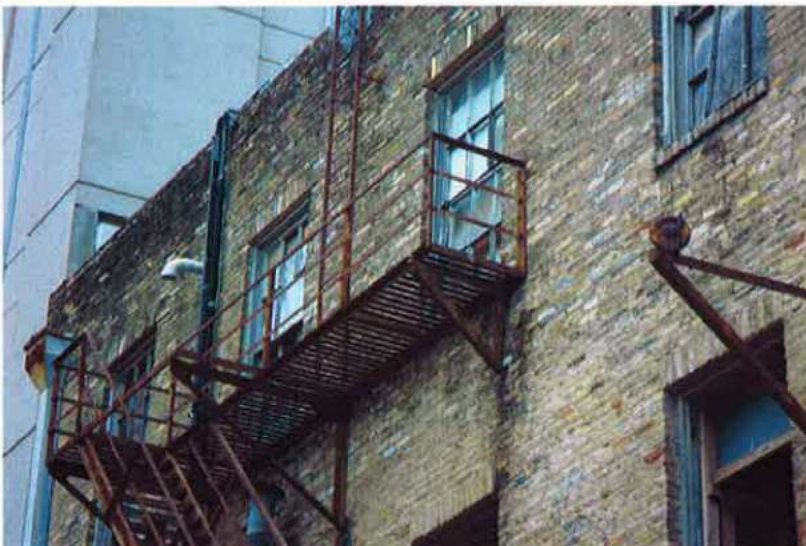
Photo 6
West Face, obsolete fire escape

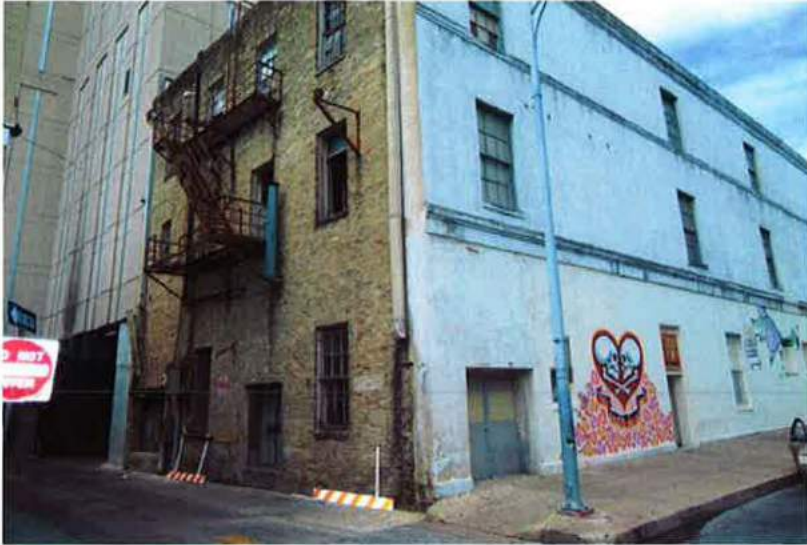
Photo 7
West Face, only original 1860's
brick façade

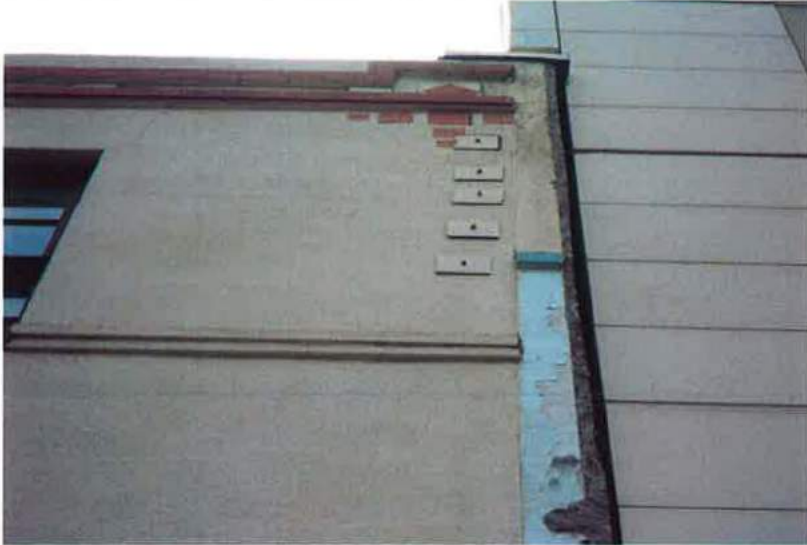
Photo 10
Close up of Photo 9
NOTE: Assumed additional Tie Rod Plates

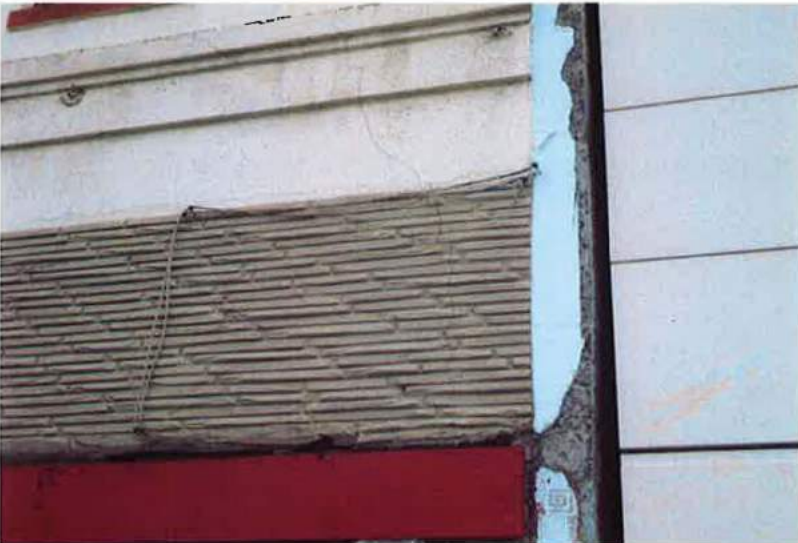
Photo 11
SW Corner above store front
NOTE: distinct cracking

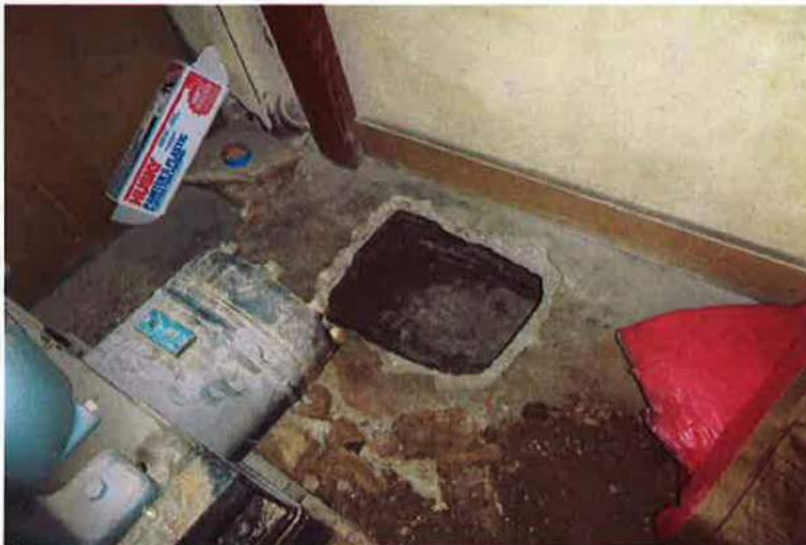
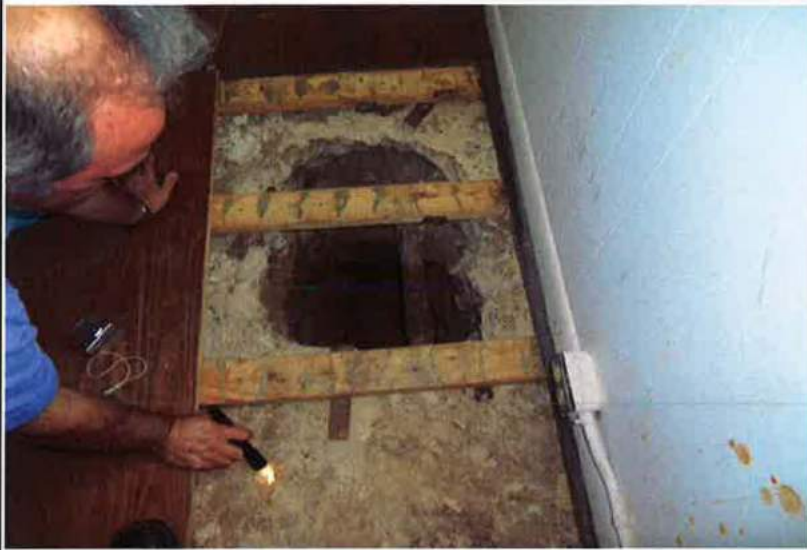
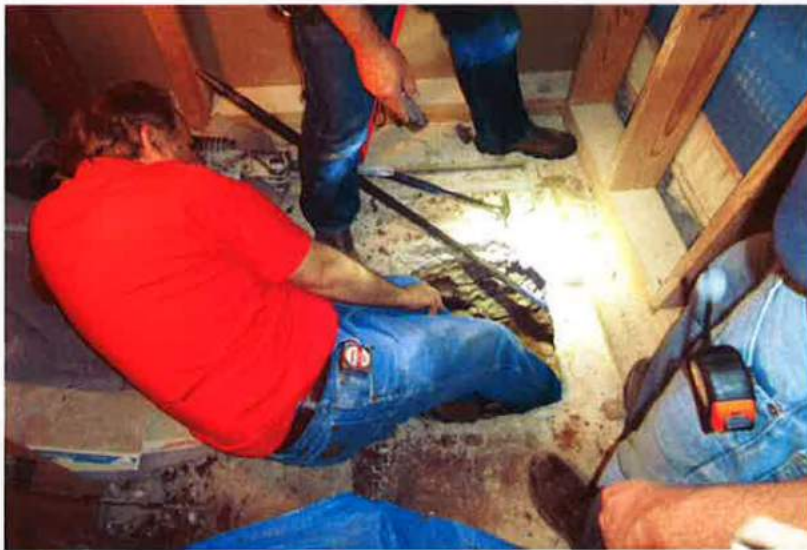
- a. A dry-stacked stone or rubble footing condition was observed at the southwest corner and along the north wall
- b. A concrete footing supporting a well mortared brick wall was observed at the southeast corner.
- c. It is impossible to know whether the majority of the existing foundations consist of dry-stacked stone or rubble footings, rather than reinforced concrete footings.

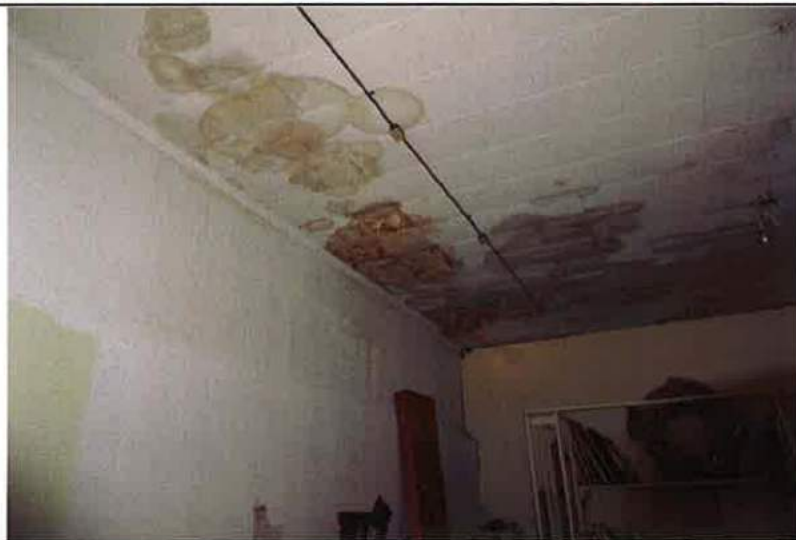
Photo 18
2nd Floor water stained ceilings
(typical through out entire floor)
